# **Hunstanton Promenade and Seawall Condition Assessment**

## **Condition Assessment Report**

Environment Agency and Borough Council of King's  
Lynn and West Norfolk

Final Report V3

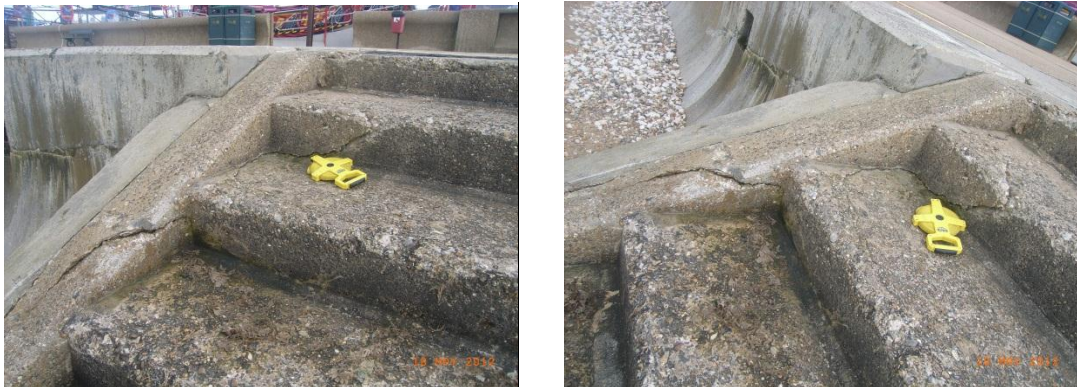
The stepped apron is overall in fair condition with only 3% of panels rated as poor condition. Panel 68, the last Section A panel, had a 3m crack exceeding 5mm width (Figure 7-2). Repairs to the crack are required to avoid further widening and subsequent loss of material as well as saline intrusion into the chalk fill foundation material. Other defects observed include widespread concrete abrasion and some sealant loss.

Figure 7-2 Significant crack across the seawall panel 68 of the Section A

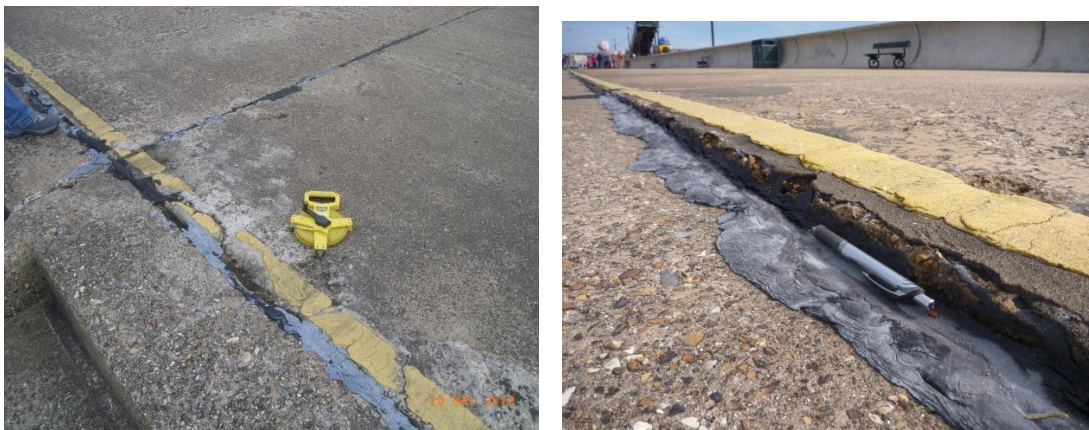
The promenade slab is in fair condition (84% of panels) with some 10% of panels in good condition as well as 3% of panels in very good condition and 3% of panels in poor condition. The most considerable areas of settlement extend from panels 33 to 42 (approximately 40m length) with a maximum settlement of 40mm of the promenade in relation to the seawall (Figure 7-3). Overall the defects observed were concrete abrasion, some sealant loss and concrete spalling. Sealant replacement and concrete patching of areas with abrasion is recommended.

Figure 7-3 Panel 64 cracking and sealant loss (left) and 40mm settlement (right)

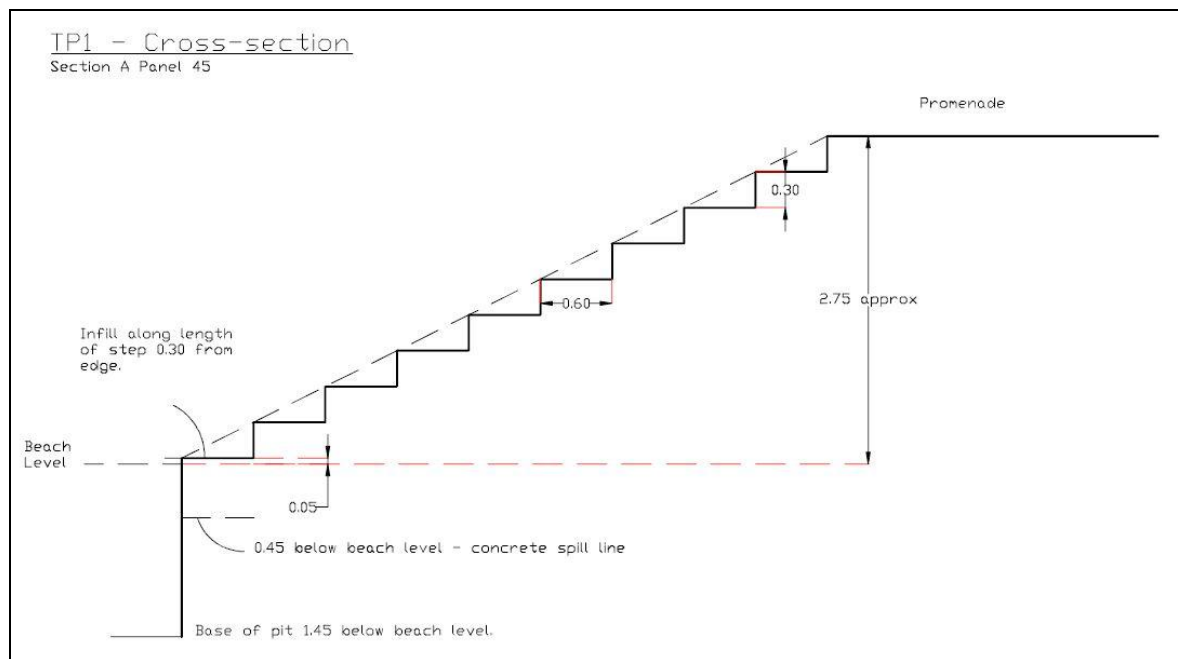
Figure 7-4: Trial Pit Cross Section

The trial pit was excavated to 1.45m below beach level. A possible hard surface was found at this location, but was partially obscured by pit side collapse. It is possible that the seawall might extend to deeper than this, but this was not verified. No defects were visible below beach level.

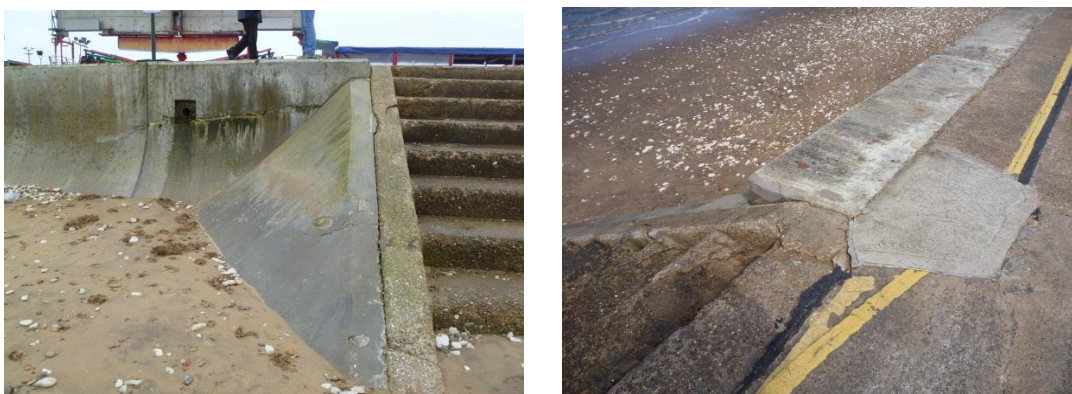
The seawall is in very good condition (79% of panels). 15% of panels are in good condition, 3% of panels in fair condition and 3% of panels are in poor condition. In Panel 1, a horizontal 2.7m long crack with a width smaller than 5mm was found below an outfall pipe and spanning between vertical joints. There was some indication of forward rotation of the top part of the seawall panel and the crack has now spread to the adjacent panel (Figure 8-2). This crack has propagated since the 2008 condition survey.

Figure 8-2 Section B, large crack observed in panel 1

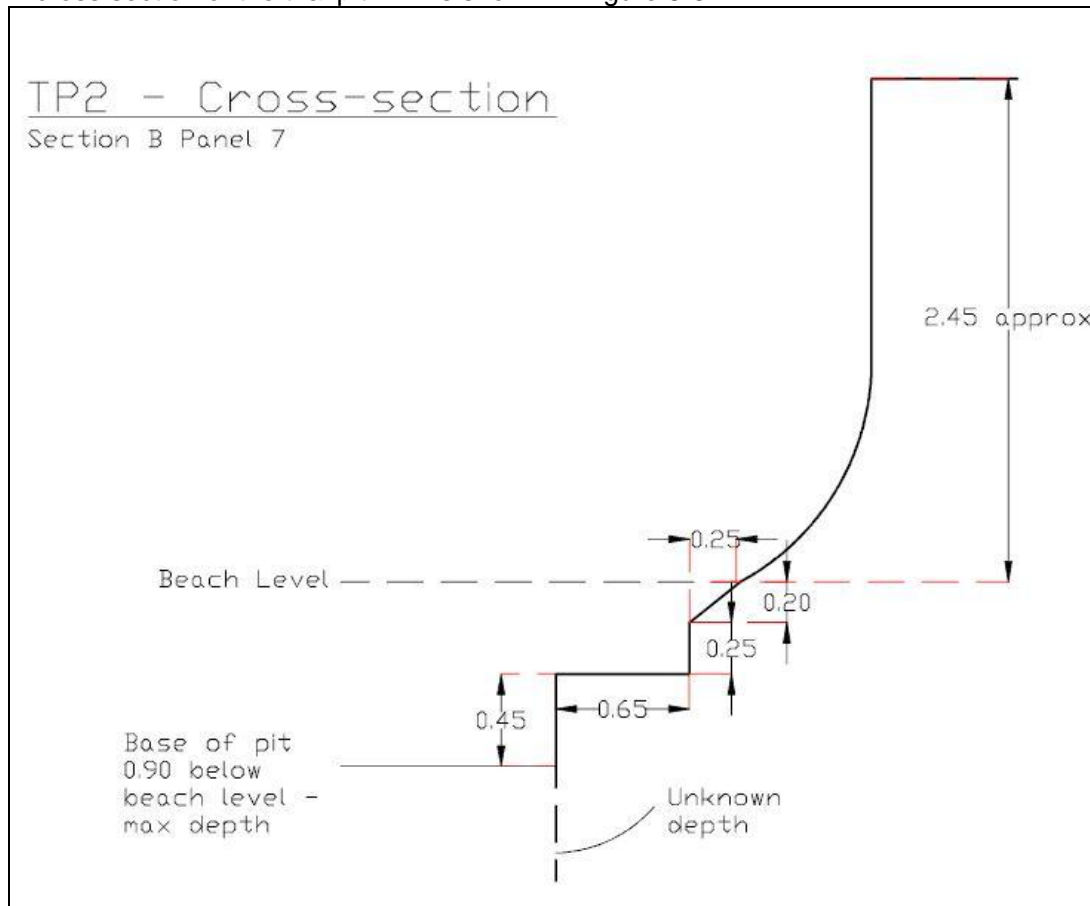
Figure 8-3: Trial pit TP2 cross section

The trial pit was excavated to 0.90m below beach level, in front of Panel 7. This was the maximum depth. Water ingress occurred from 0.45m. The seawall toe foundation depth was unknown. No defects were visible below beach level and the seawall was in reasonable condition.

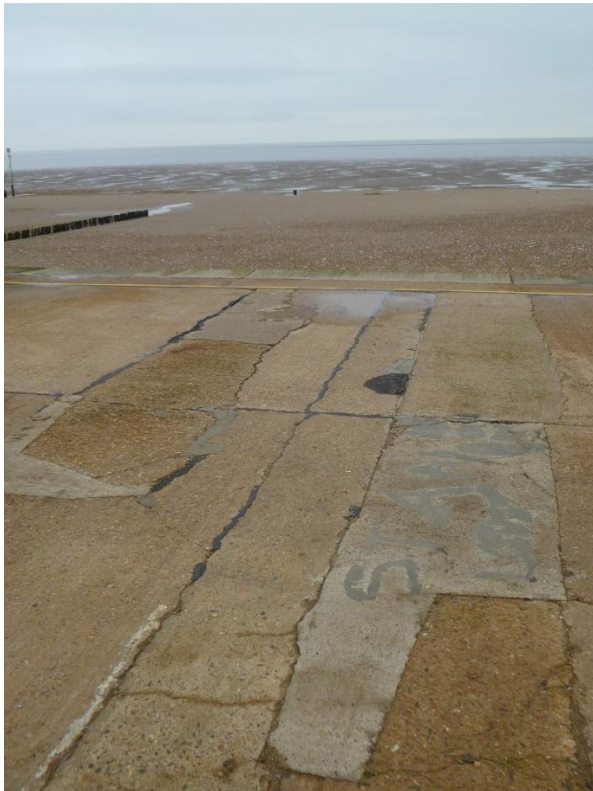
The promenade slab is generally in fair condition (64% of panels). Some 36% of the panels are in good condition. Defects observed include concrete spalling, sealant loss, cracking and settlement. Areas for which previous patch repairs have taken place were also observed (Figure 9-2). Sealant replacement and patch repairs of cracks are recommended.

Figure 9-2 Promenade slab with heavy patch repairs

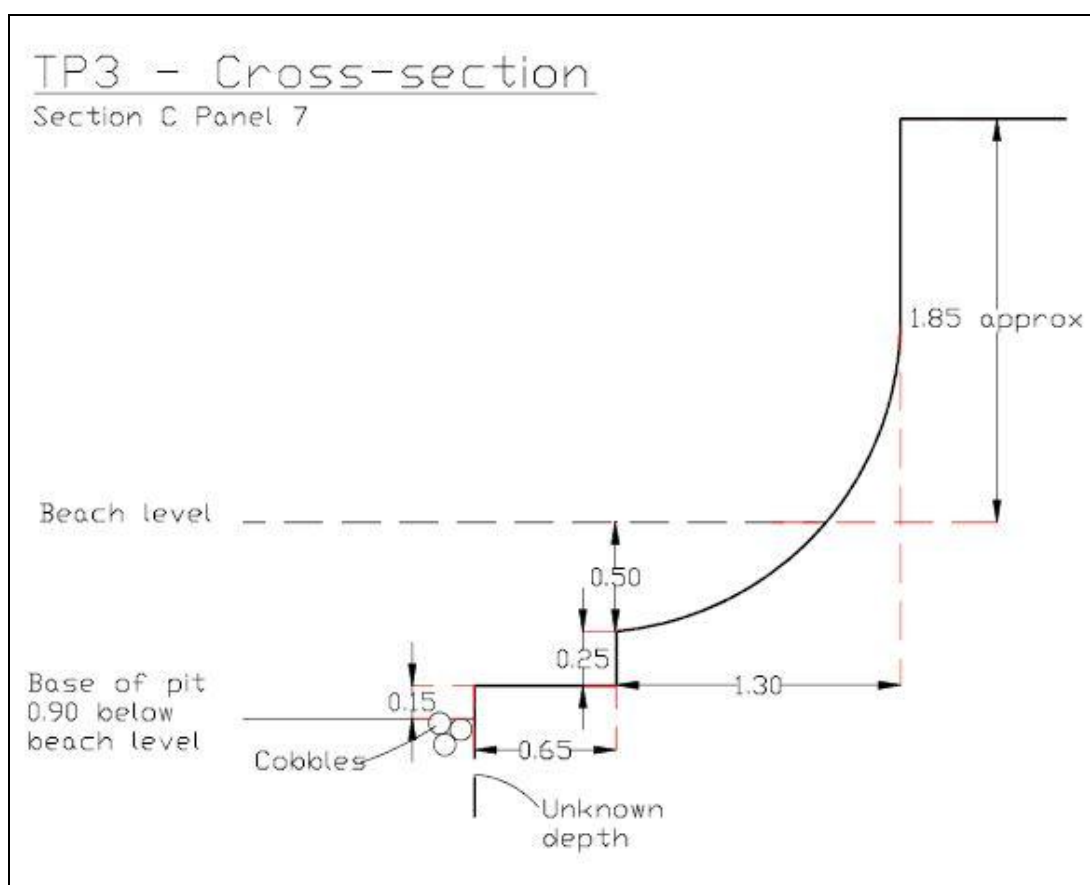
Figure 9-3: Section C Panel 7 trial pit cross section

The trial pit was excavated to 0.90m below beach level, in front of Panel 7. Water ingress occurred from 0.60m. The seawall toe foundation depth was unknown. Cobbles of dimensions 80mm x 100mm x 100mm were present at the base of the pit. No defects were visible below beach level and the seawall was in reasonable condition.

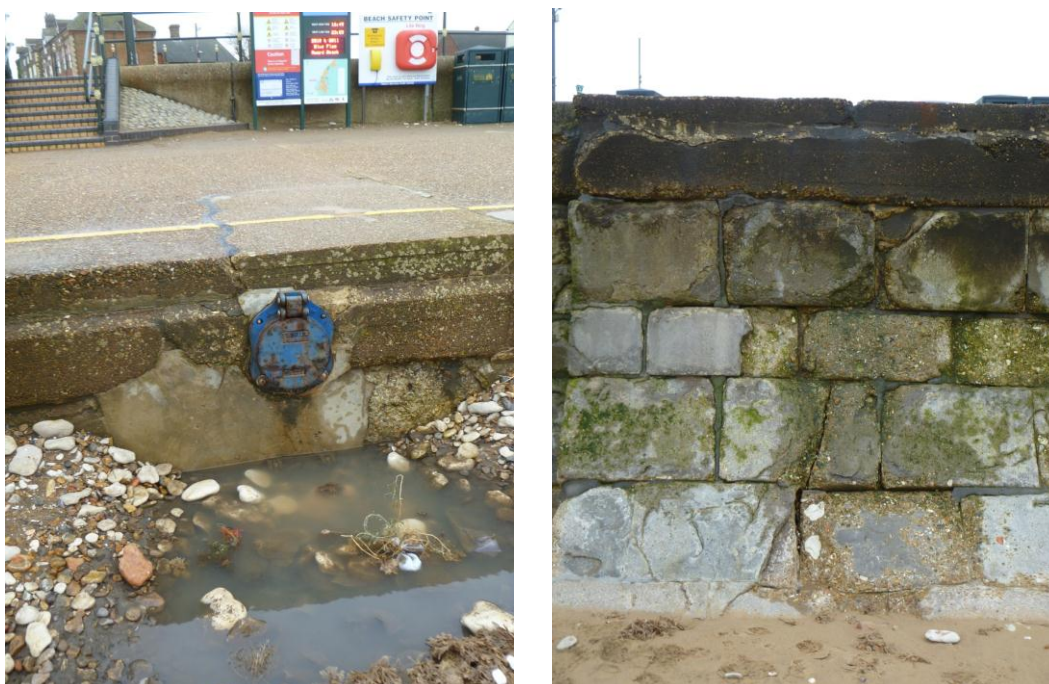
The mass concrete seawall is in fair condition (91% of panels) with 5% panels in poor condition, 2% of panels in good condition and 2% of panels in very good condition. Concrete abrasion (particularly at the edge of blocks), sealant loss and cracking of blocks were the most noticeable and frequent defects. Sealant loss and cracking are likely to lead to saline intrusion, further concrete abrasion and concrete spalling as well as loss of material from the foundation of the promenade. Several outlet points can be found throughout the seawall and they are likely to contribute towards the deterioration of the seawall (Figure 11-2).

Figure 11-2 Outfall at panel 5 and seawall panel in poor condition (left), typical seawall panel condition (right)

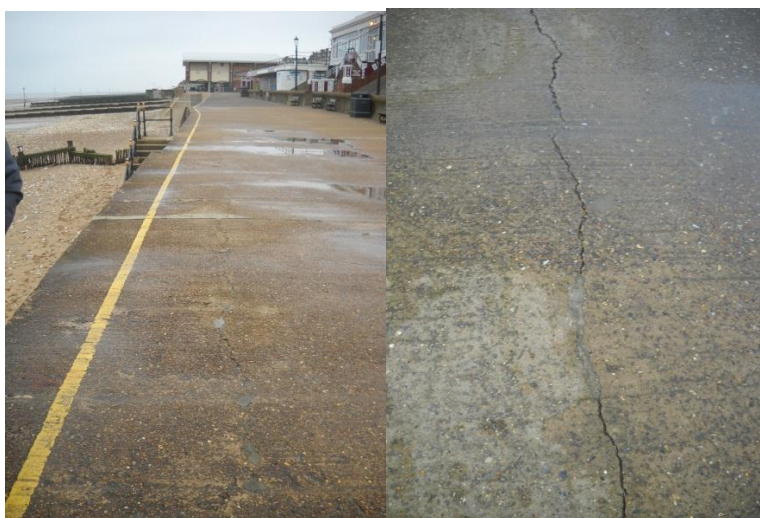
The promenade slab in Defence Section E is generally in fair condition (69% of panels), with 20% of panels in good condition, 4% of panels in very good condition and 7% in poor condition. Typical defects observed include significant cracks, spalling spots and patch repairs. A 35m long crack was observed on the promenade extending from panels 37 to 43 (Figure 11-3). Since the Mott MacDonald investigation (1996) this crack has propagated an additional 3m. There has been 10mm settlement at the central line between the rear and front section of Panel 39. This may be evidence of ground movement between the panels.

Figure 11-3 35.4m long crack spanning between planes 37 to 43

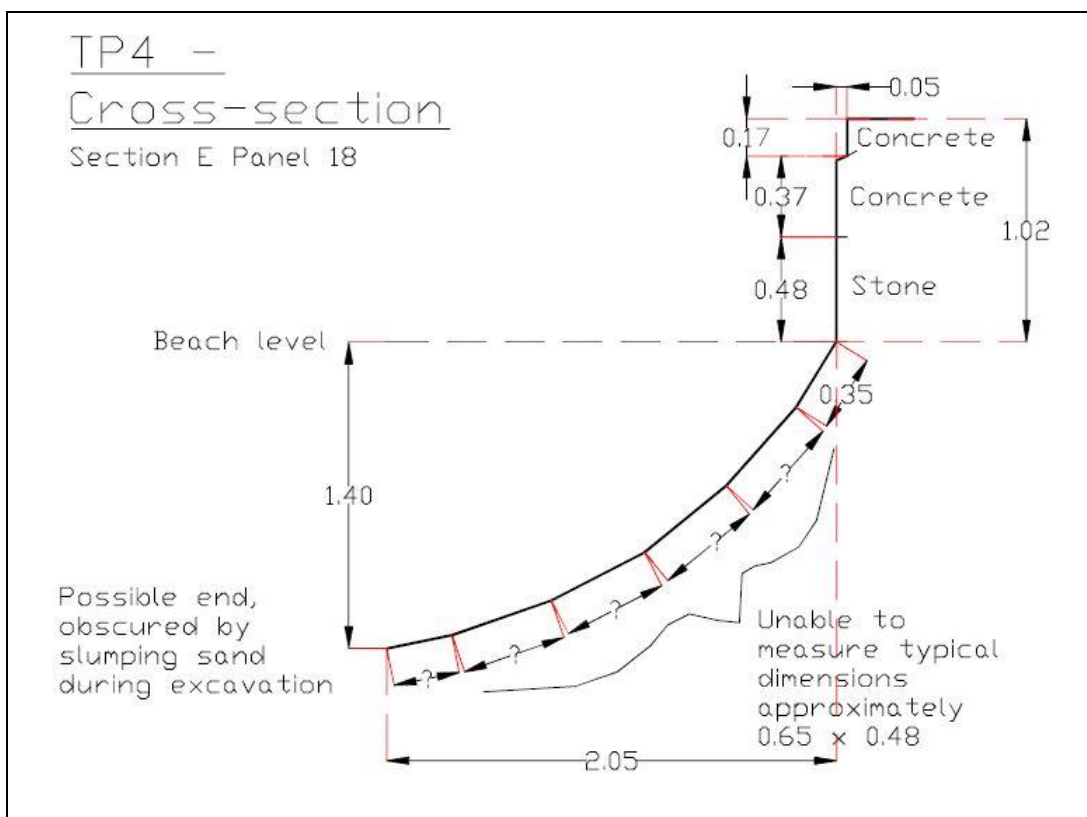
Figure 11-4: Trial Pit TP4 Cross Section

Trial pit TP4 was excavated to 1.40m beneath beach level at Panel 18. A maximum six slabs were observed down to this depth. After this depth, sand slumped into the pit, obscuring further slabs. Overall the slabs showed some wear, with cracked surfaces at the joints. Some infill had occurred at the joints. Water Seepage was visible from 0.60m below beach level.

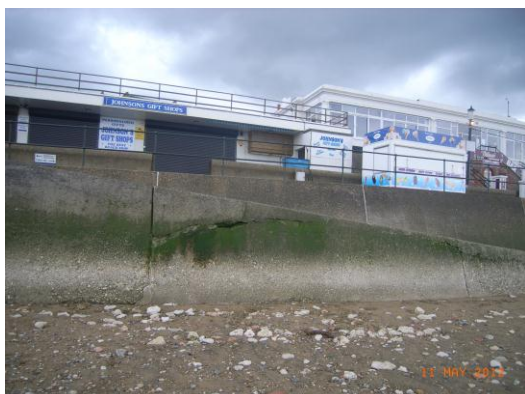
In defence Section F there are two sets of seawall panels, some supporting the slipway and some supporting the promenade. Overall the seawall panels are in fair condition (88% of panels). Panel 3 supporting the seawall is in poor condition due to the presence of a horizontal 3m crack with a maximum width of 20mm (Figure 12-2). Sealant loss was apparent between the slipway slab and the seawall section underneath. There was also sealant loss between vertical joints of the panels exposing underlying material. Concrete abrasion and hairline cracking was also prominent.

Figure 12-2 Crack at seawall panel 3.

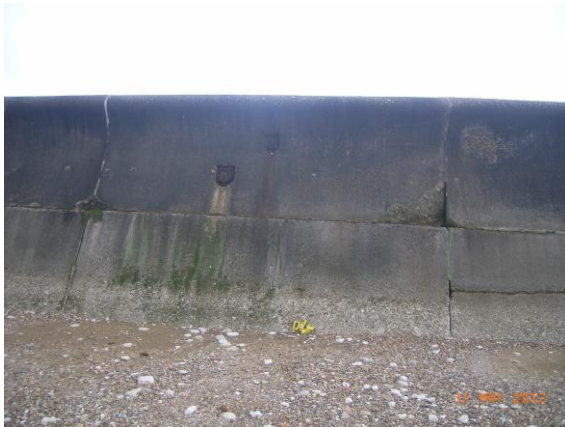
The promenade slab in defence Section G is in very good condition (88% of panels) with some 12% of panels in good condition. The main defect observed was cracking of the slab (Figure 13-2).

Figure 13-2 Section G seawall panel with cracking at joints and loss of concrete

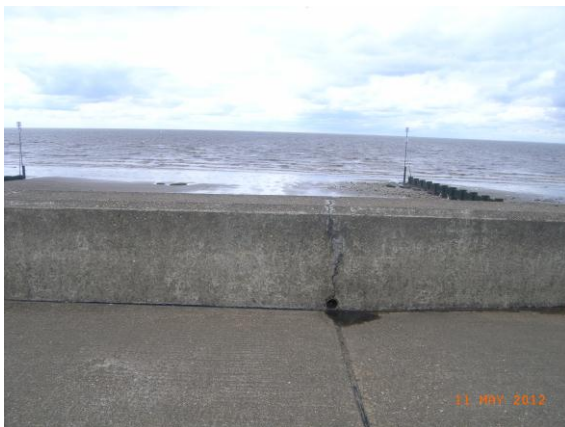
The upstand recurve wave wall is in very good condition (73% of panels) with 27% of panels in fair condition. The main defect observed was cracking across the length of the upstand recurve wave wall at the locations with surface water outlet points (Figure 13-3).

Figure 13-3 Recurve wave wall upstand with cracking at an outlet point
