Hunstanton Coastal Defence Capital Works Briefing

Monday 20th October 2025

Outcomes of Geotechnical Investigations

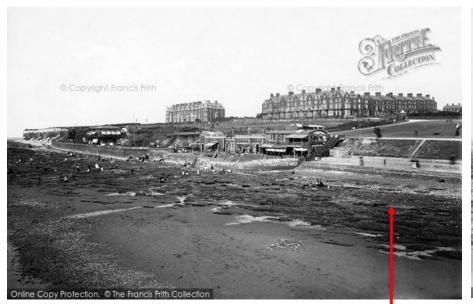
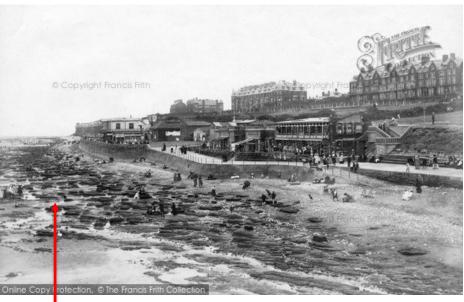
Hunstanton in 1893 & 1907 – Similar beach conditions to today

Widespread Carstone exposure and limited beach cover is evident

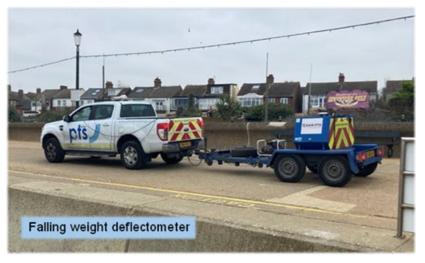
Section A (Boat Ramp / Caravan Park)

Wave-return wall – No current works required

Promenade deck – Poor concrete condition and voids

Stepped seawall – No refacing works required

- No toe protection works or sheet piling required

Window sampling required within next 12 months

Potential replacement of prom deck required (up to 68 panels)

Monitoring – Regular monitoring of beach levels

Structural stability monitoring every 5-years
