# **Hunstanton Promenade and Seawall Condition Assessment**

## **Condition Assessment Report**

Environment Agency and Borough Council of King's  
Lynn and West Norfolk

Final Report V3

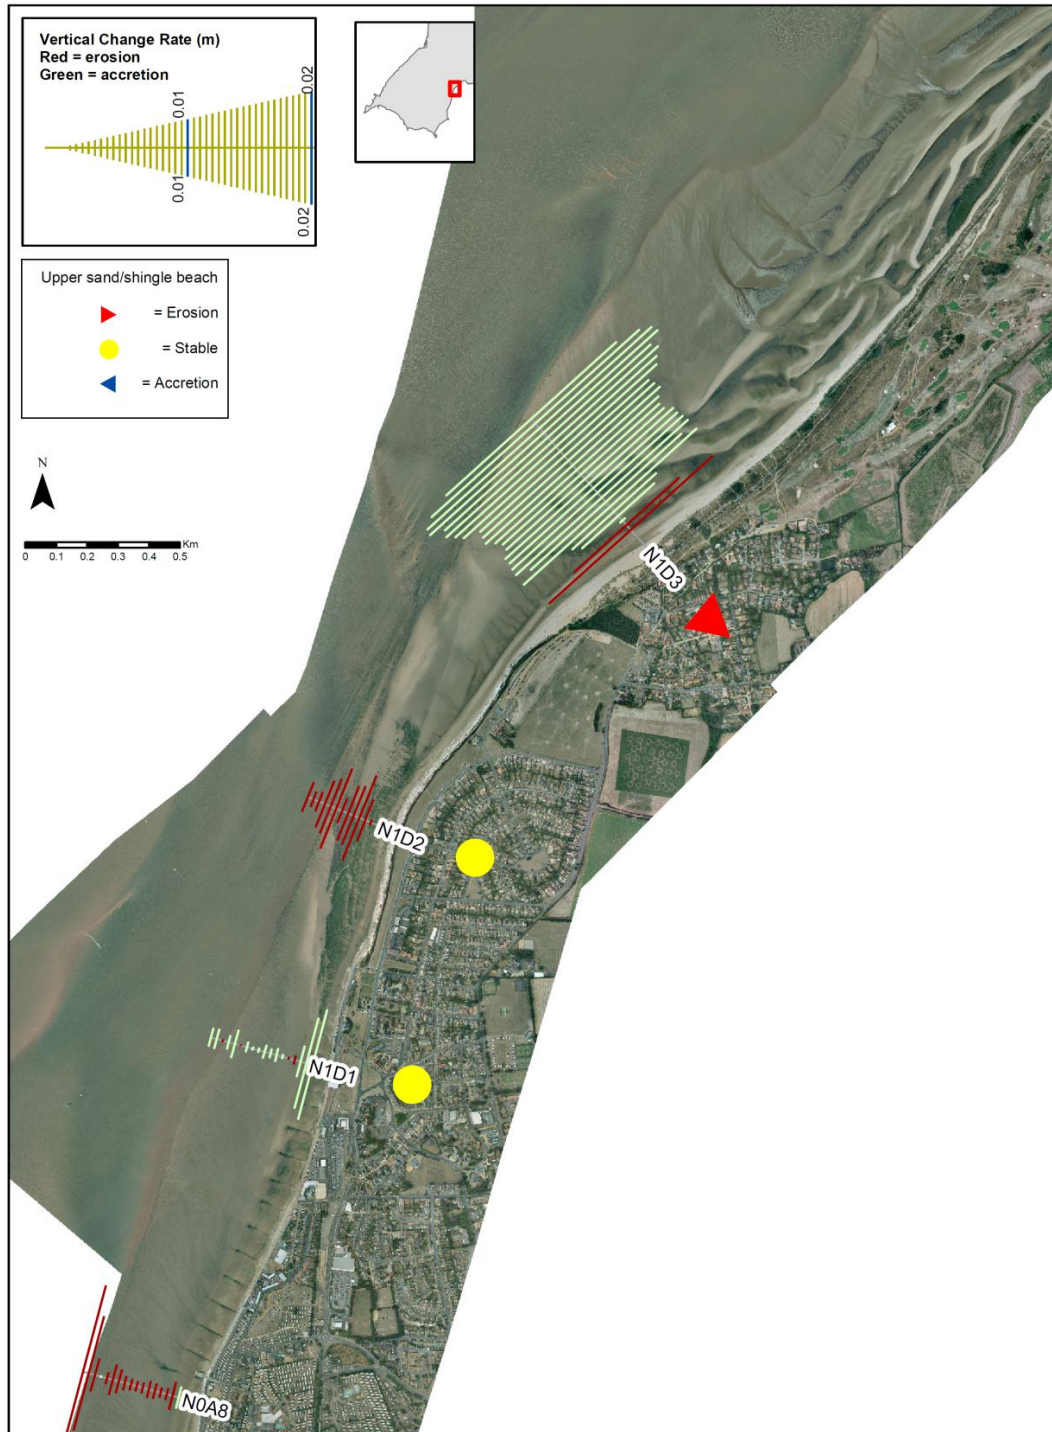
Figure 5-2 Coastal trend analysis of profile N1D1

The N1D1 beach profile data from 1991 to 2006, presented in the Coastal Trends Analysis (EA, 2007), has been assessed for this condition assessment. Figure 5-2 presents a summary figure for this profile. Horizontal erosion trends of around  $1.5\text{myr}^{-1}$  are shown on the upper foreshore, with horizontal accretion at approximately mean sea level. This indicates a trend of profile flattening. Conversely, the lower sand and mud flat show a strong vertical accretion of approximately  $0.4\text{myr}^{-1}$  over this time period.

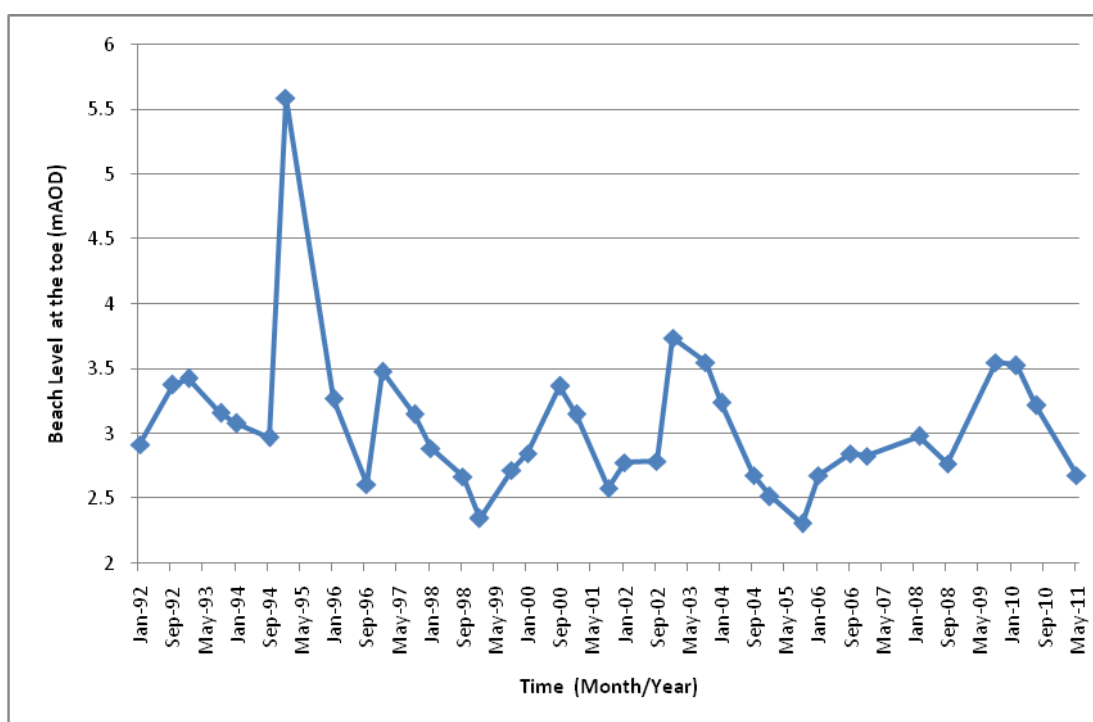
Figure 5-3 Beach variability at the toe of the defence, profile N1D1

For the performance and residual life of the defence the most important beach level parameter is the beach level at the toe of the structure. This level affects the stability of the seawall and determines the degree of toe undermining. Analysis of beach levels in front of the seawall was undertaken and shows that beach levels directly in front of the seawall vary. Between January 1992 and May 2011 beach levels varied from approximately 3.5 to 3.75mODN at their highest down to approximately 2.25mODN at their lowest, giving rise to a variation in beach levels of up to 1.5 metres (Figure 5-3). This change has occurred over a 2 to 2.5 year timescale. The value of 5.59mODN, seen in 1995 is extremely high and would indicate that the beach levels were high enough to almost reach the crest of the defences at section A-E. Since there are no records of such conditions this value can be excluded from the analysis. The largest variations in any one year, around 1m, can be observed in 1996, 2002 and 2008. This overall variability indicates that the beach has a relatively high response to the wave environment, but the overall trend is one of no movement.
